SOUTH FORK CLEARWATER RIVER HABITAT ENHANCEMENT
NEZ PERCE NATIONAL FOREST

Project Number 84-5
Contract Number **DE-AI79-84BP16475**

April, 1992

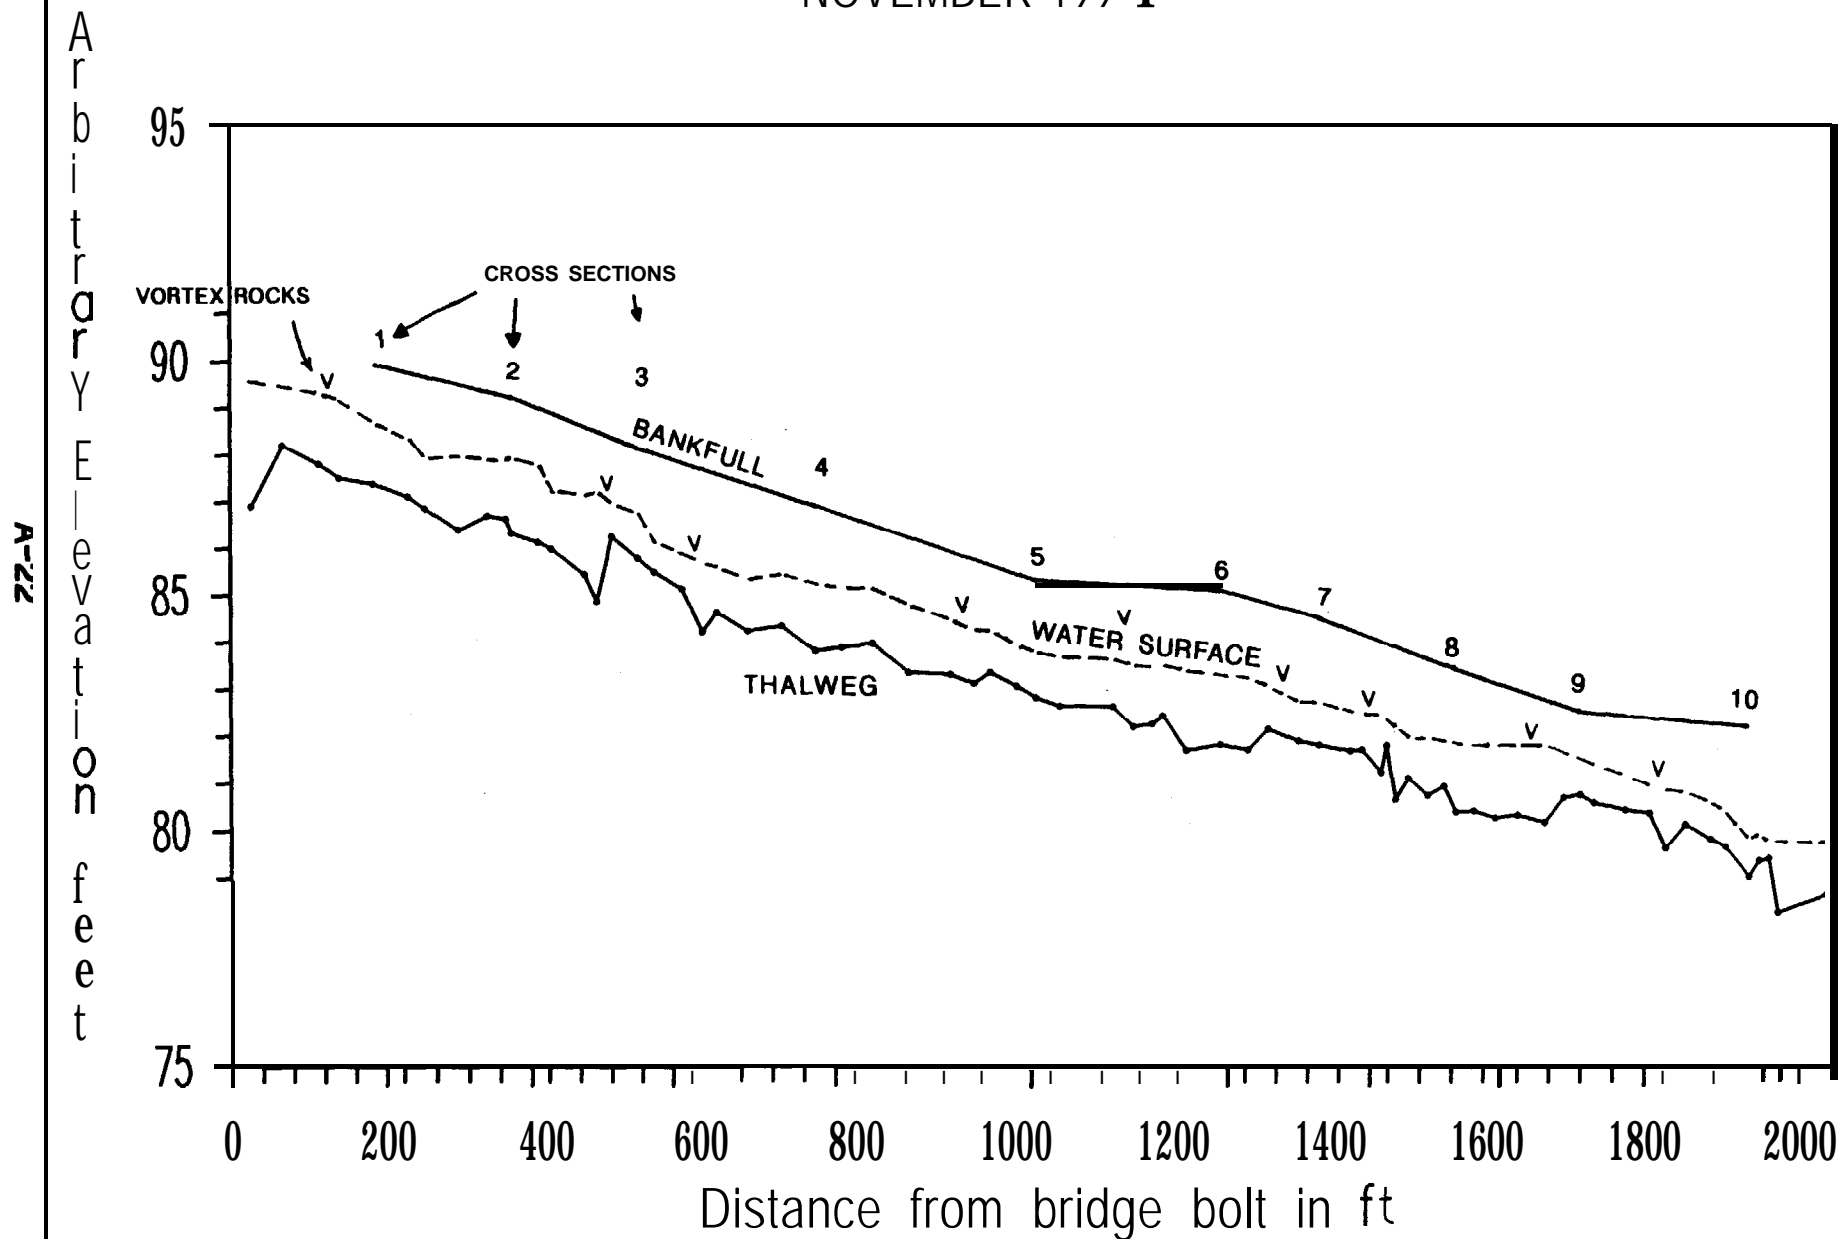
FIG 10 RED RIVER LONG PROFILE

Channel Surveys: Permanent monuments were installed in the fall of 1991 at the **endpoints** of 10 cross sections. Figure 11 shows their locations. These cross sections and the longitudinal profile (Figure 10) were surveyed in November of **1991**. Average values for width, depth and cross section area are given in Table 1. These cross sections are different from those surveyed in October of 1990 before project construction (see Figure 12 for locations). Three of those that are oriented similarly are superimposed to compare **pre-** and post-project channel shapes in Figure 14. All survey data are filed in the 2630 monitoring file at the Ranger Station.

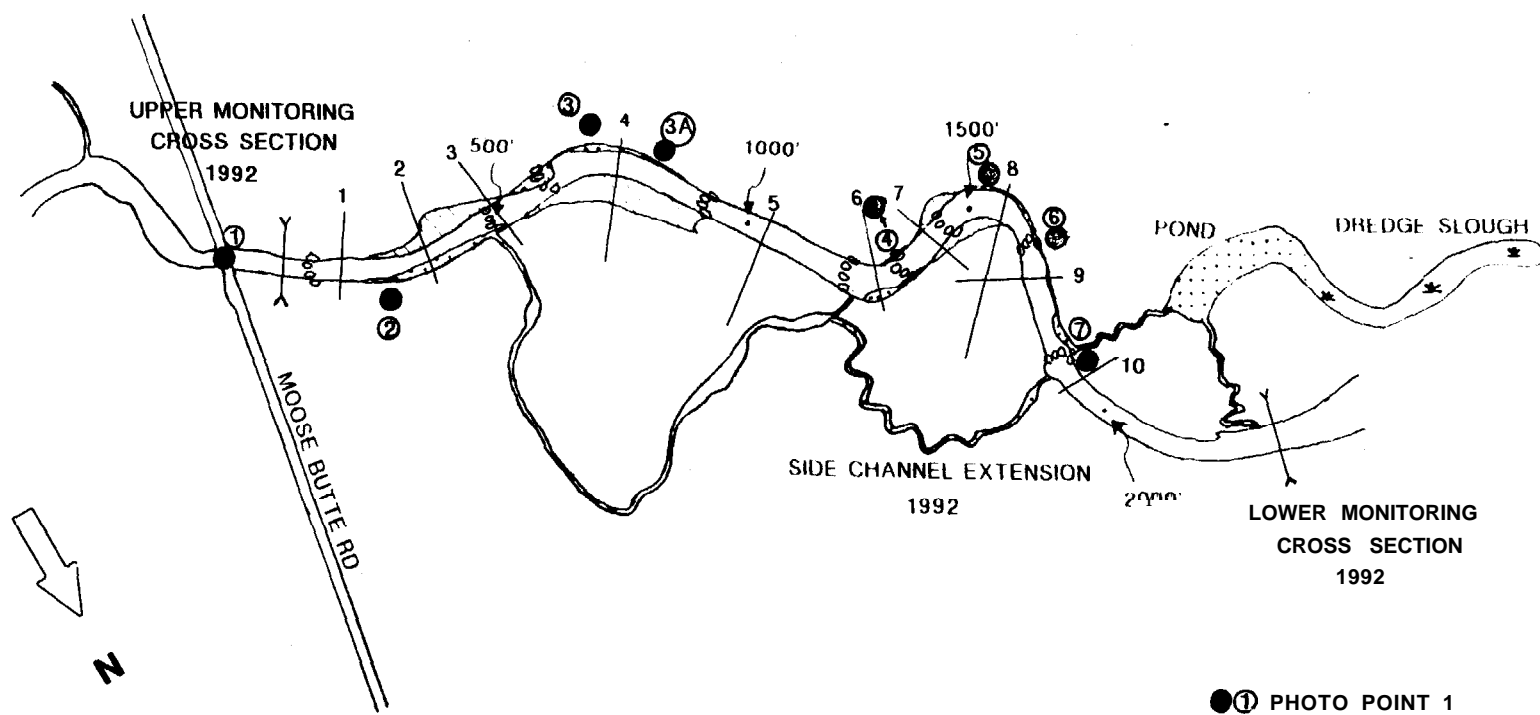
FIG 11
LOCATIONS OF SURVEYED CROSS SECTIONS & OTHER MONITORING STATIONS

In 1992, a staff gage was installed on the north-west abutment of the Moose Butte bridge. The **stage-**discharge curve will be established during 1992, and suspended and **bedload** samples will be taken weekly both up- and downstream of the project reach. Monitoring cross sections are located on Figure 11. The objectives of this effort are to:

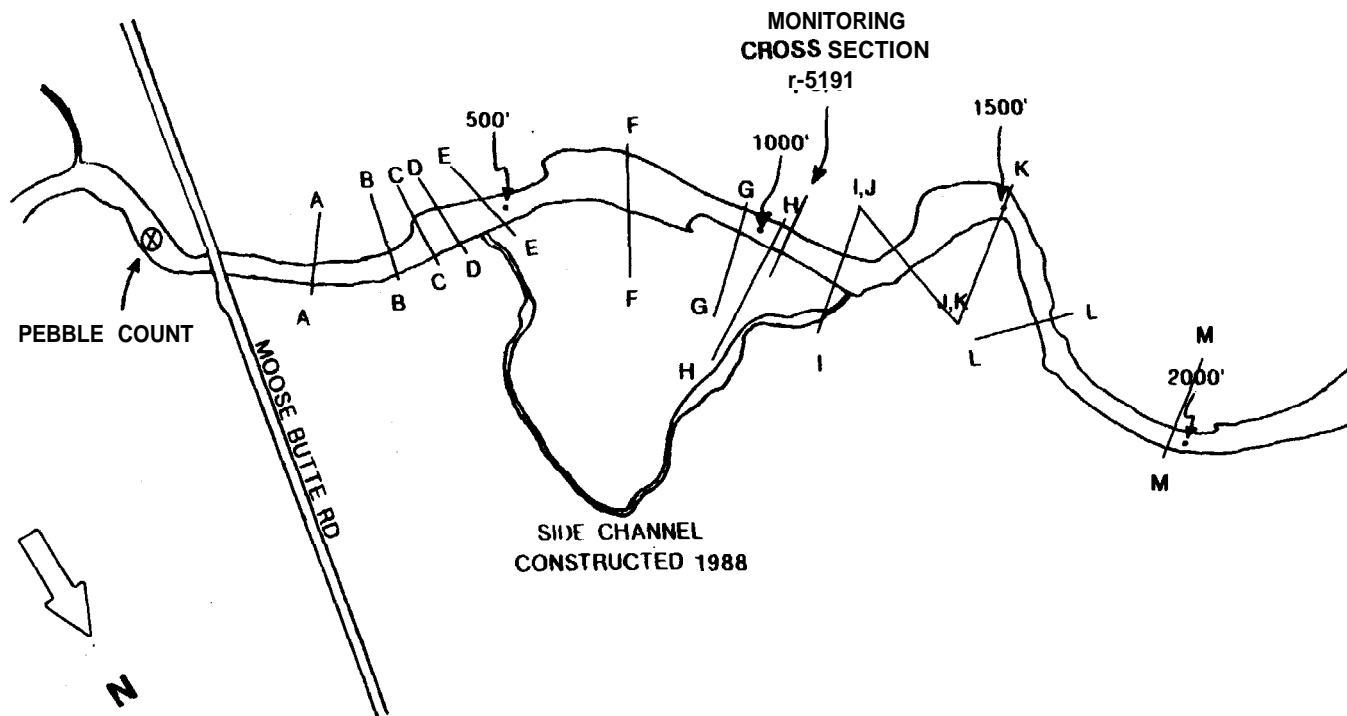
FIG 12

Discharge and Sediment Load Monitoring: Figure 12 shows the location where three discharge and **bedload** measurements were taken in spring 1991.

Pebble Counts: A Wolman pebble count was done in April 1992 in a glide just above the Moose Butte bridge (see Figure 12 for location) to estimate pre-project bed material size distribution. D_{50} was 40mm (very coarse gravel), and D_{84} was 95 mm (small cobble). During the summer of 1992, pebble counts will be taken in the project reach at three locations to determine if and how bed material size distribution was altered by the project. These counts, and the count above the bridge, should be repeated when the cross section surveys are done to define any changes over time. These data should confirm the sediment load monitoring results and will assist biologists in assessing fish habitat quality and medium term trends in the project reach.

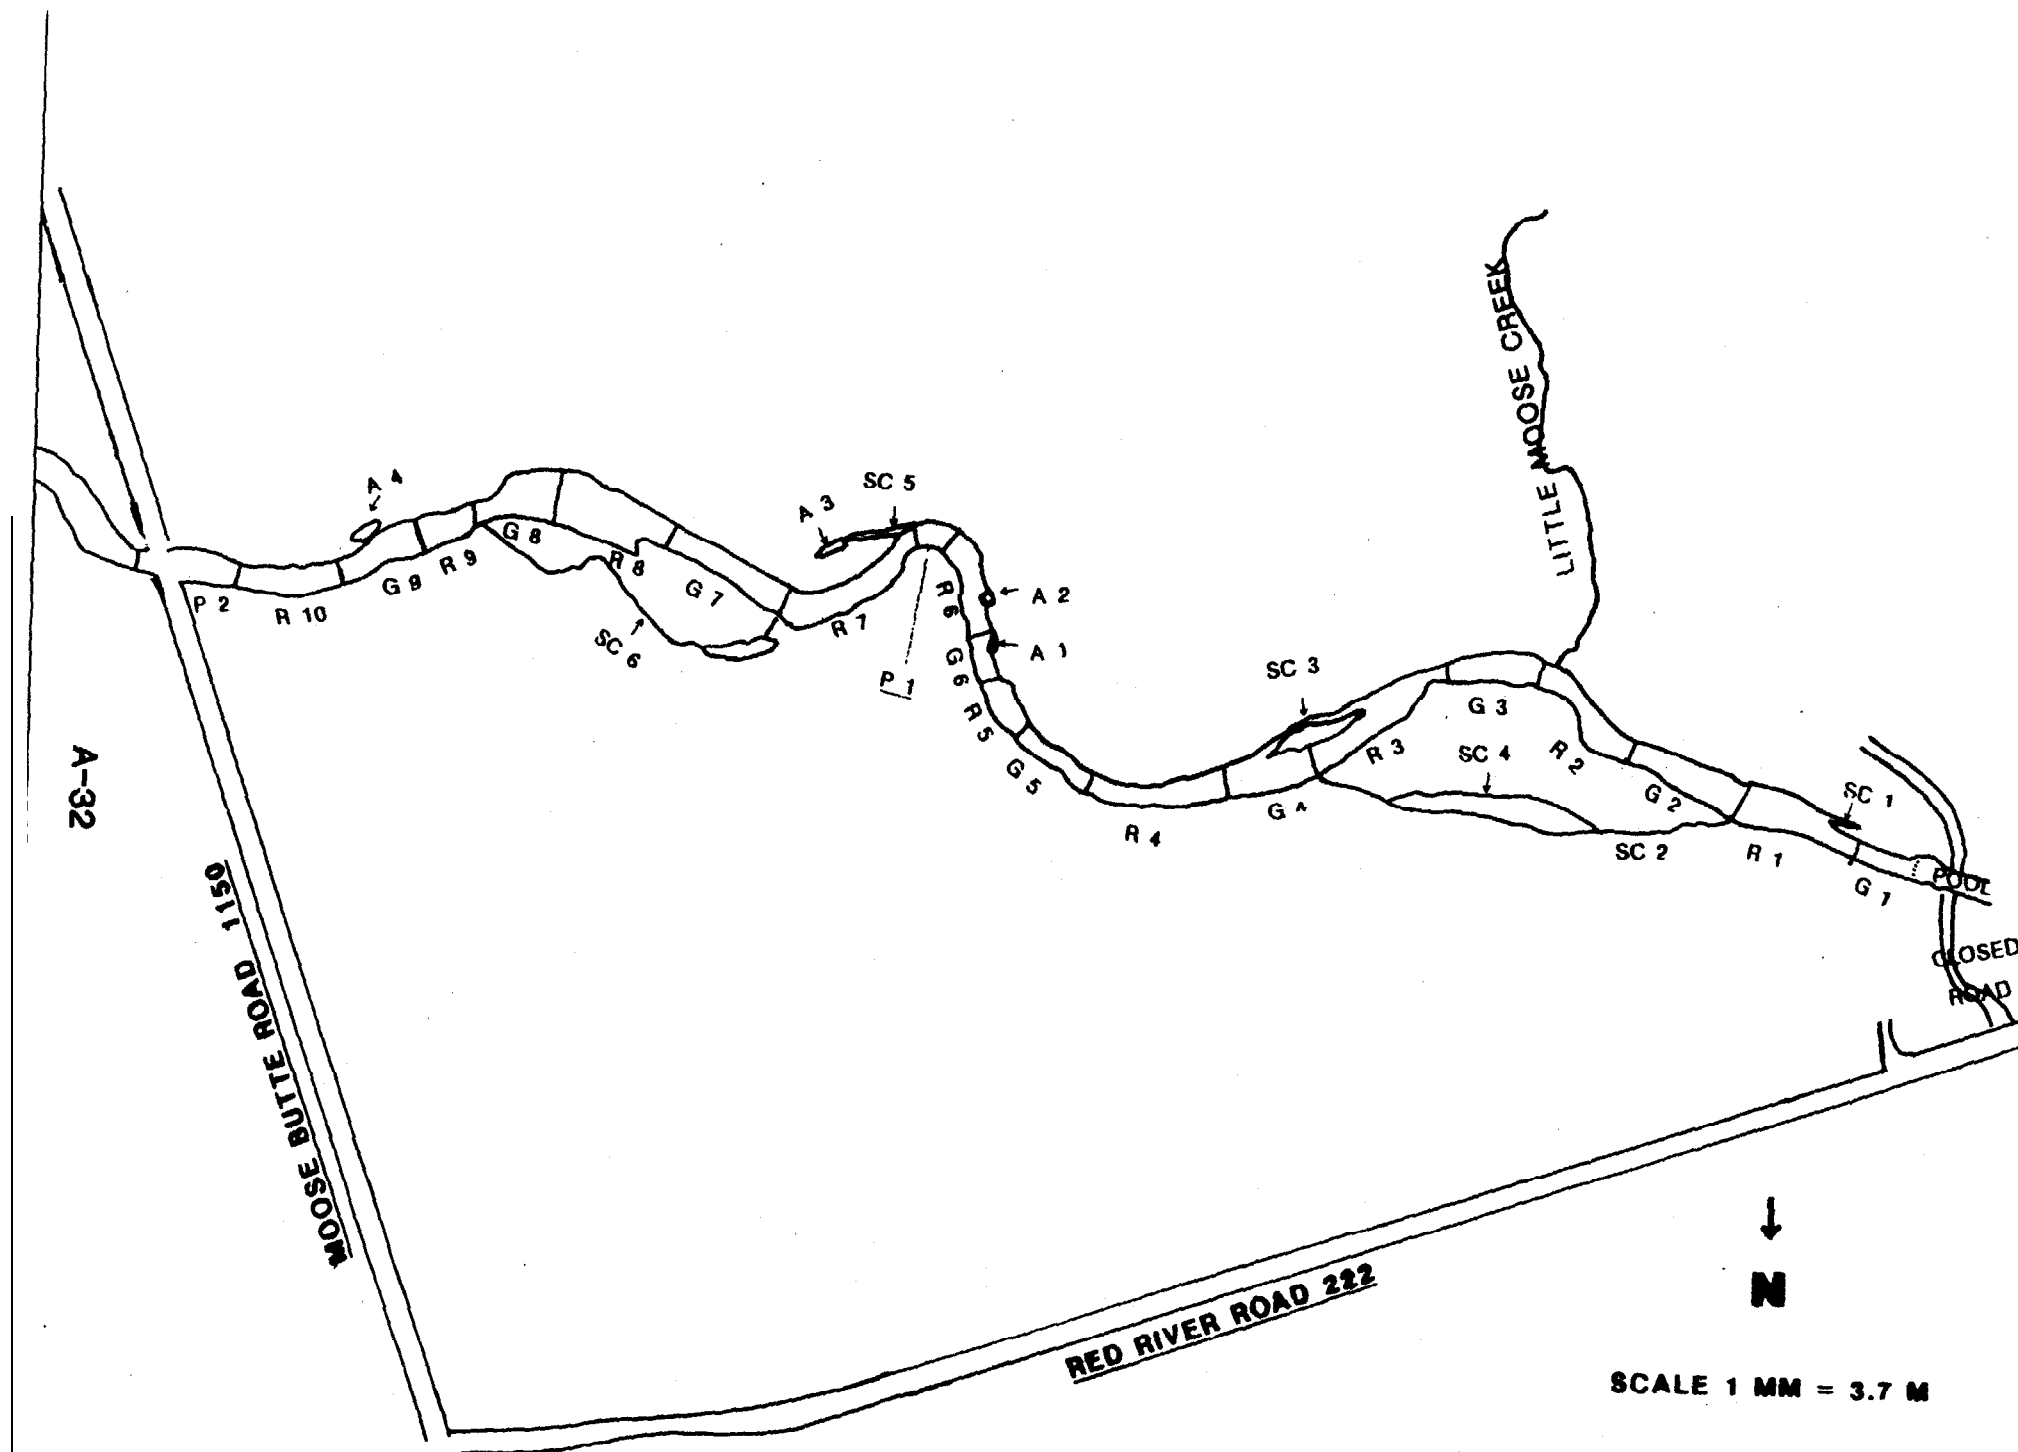
FIG 15 THE HABITAT UNIT SEQUENCE IDENTIFIED DURING THE 1990 STREAM SURVEY

Pool quality, a rating ranging from one to five (five being highest quality) and based on size, depth, and cover, was five for the two pools present in the surveyed reach. Instream cover, recorded as the percentage of the habitat unit that had cover originating from surface turbulence, instream vegetation, woody debris, or undercut banks, was low and averaged $5\% \pm 0.03\%$ for glides, $6\% \pm 0.07\%$ for riffles, and $19\% \pm 2.33\%$ for pools. Instream cover rating for pools was significantly different from riffles ($q=6.20$, $P<0.01$). Instream cover was similar for riffles and glides ($q=0.96$, $P>0.25$). Bank cover, recorded as the percentage of the habitat unit that had cover originating from overhanging vegetation or undercut banks was also low and was $3\% \pm 0.15\%$ for all habitat types. Bank stability, the percentage of the habitat unit lined with stable banks, was $70\% \pm 0.33\%$ for all habitat types.

During the survey the average cobble embeddedness was visually estimated to be 25%; this estimate is uncharacteristically low for Red River. However, the survey crew was inexperienced at collecting this parameter and probably underestimated cobble embeddedness. It is likely that cobble embeddedness was closer to 50%-70%. Cobble embeddedness measured using methods adopted from Burns (1984) at
